Wetland Delineation

Clinton Manufacturing Drive Reconstruction

6/17/2020

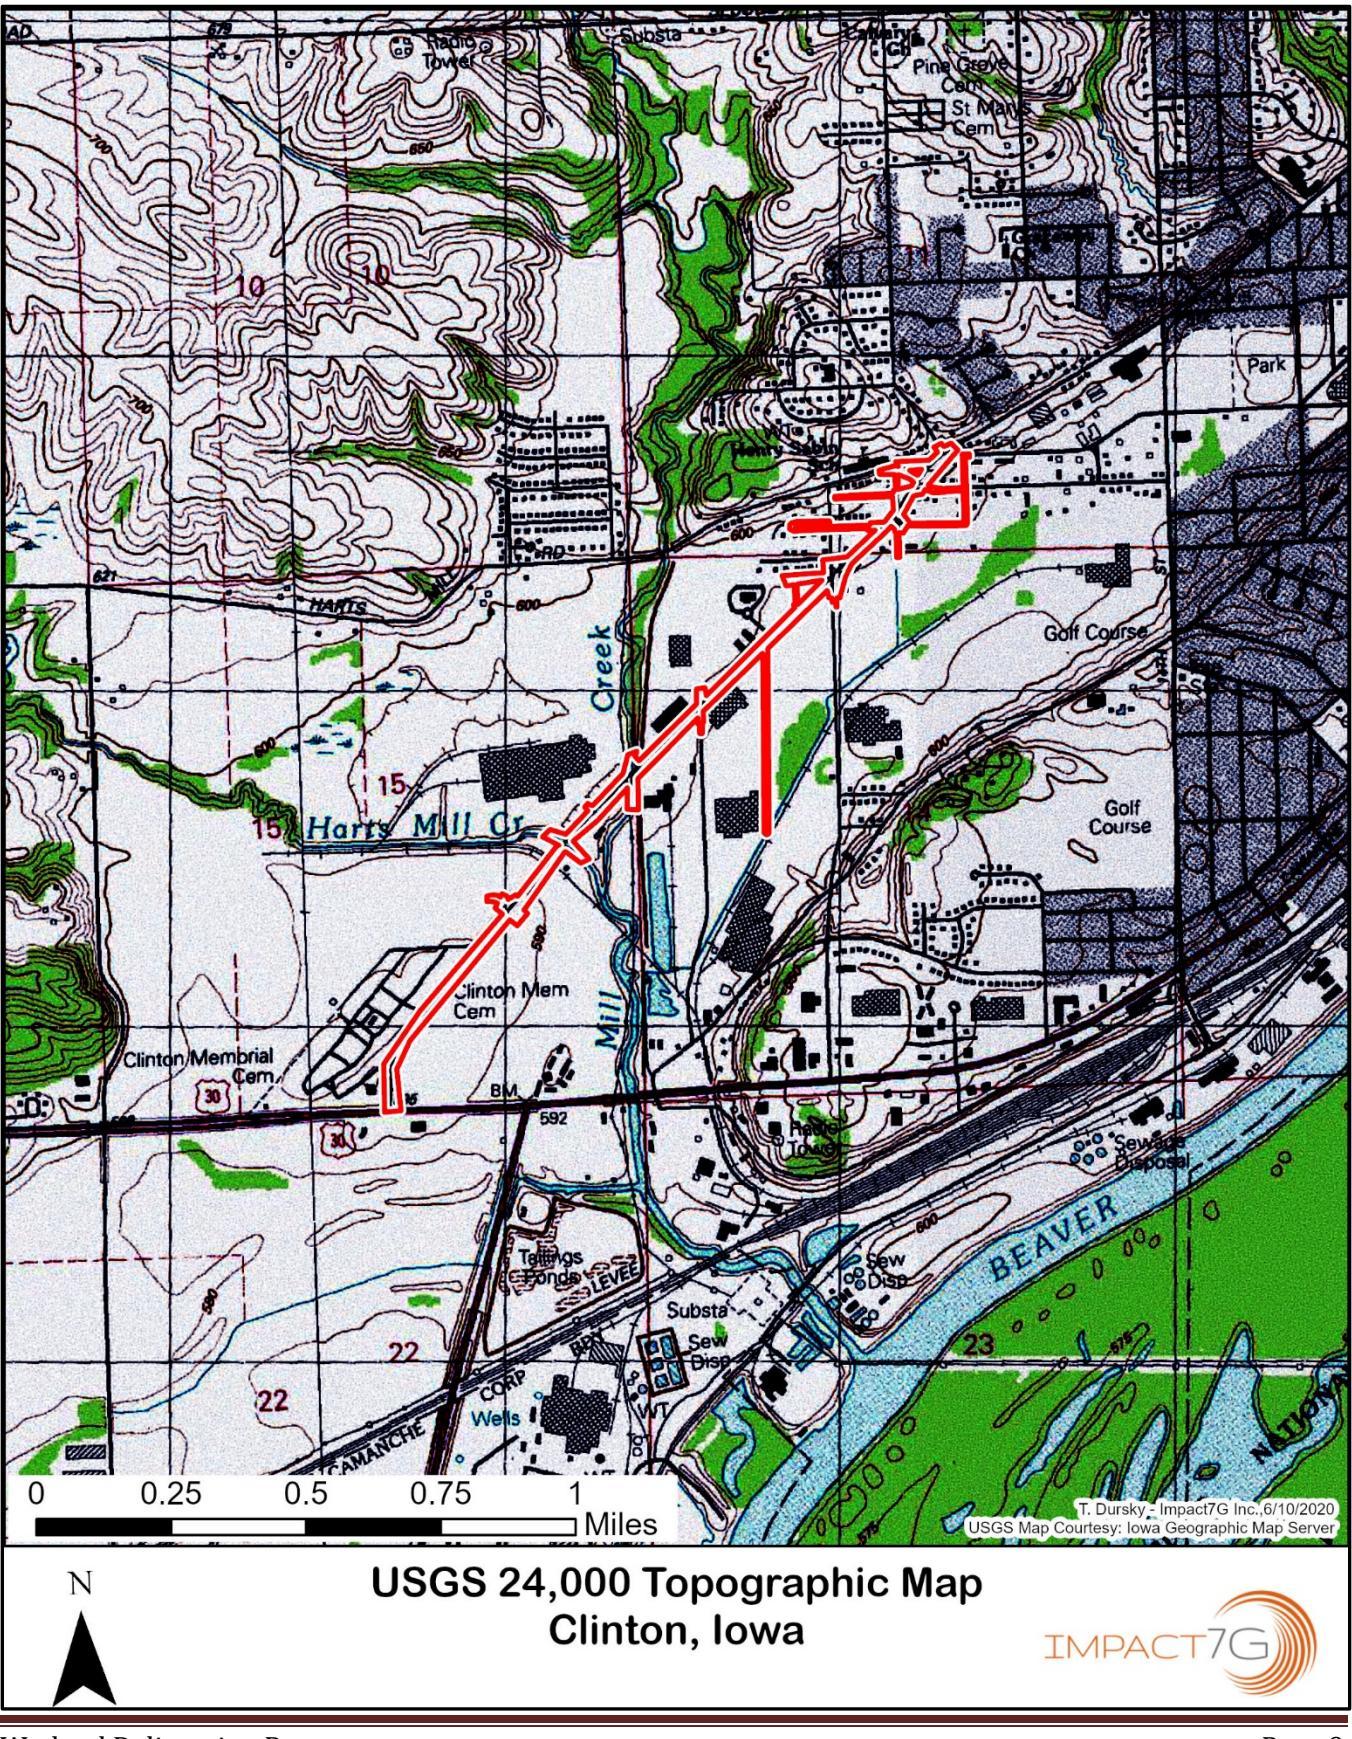
Figure C: USGS Topo 7.5 Minute Quadrangle Map (1:24,000)

Tributary name information reflects data provided from the United States Geological Survey (USGS) 1:24,000 topographic maps (Figure C).

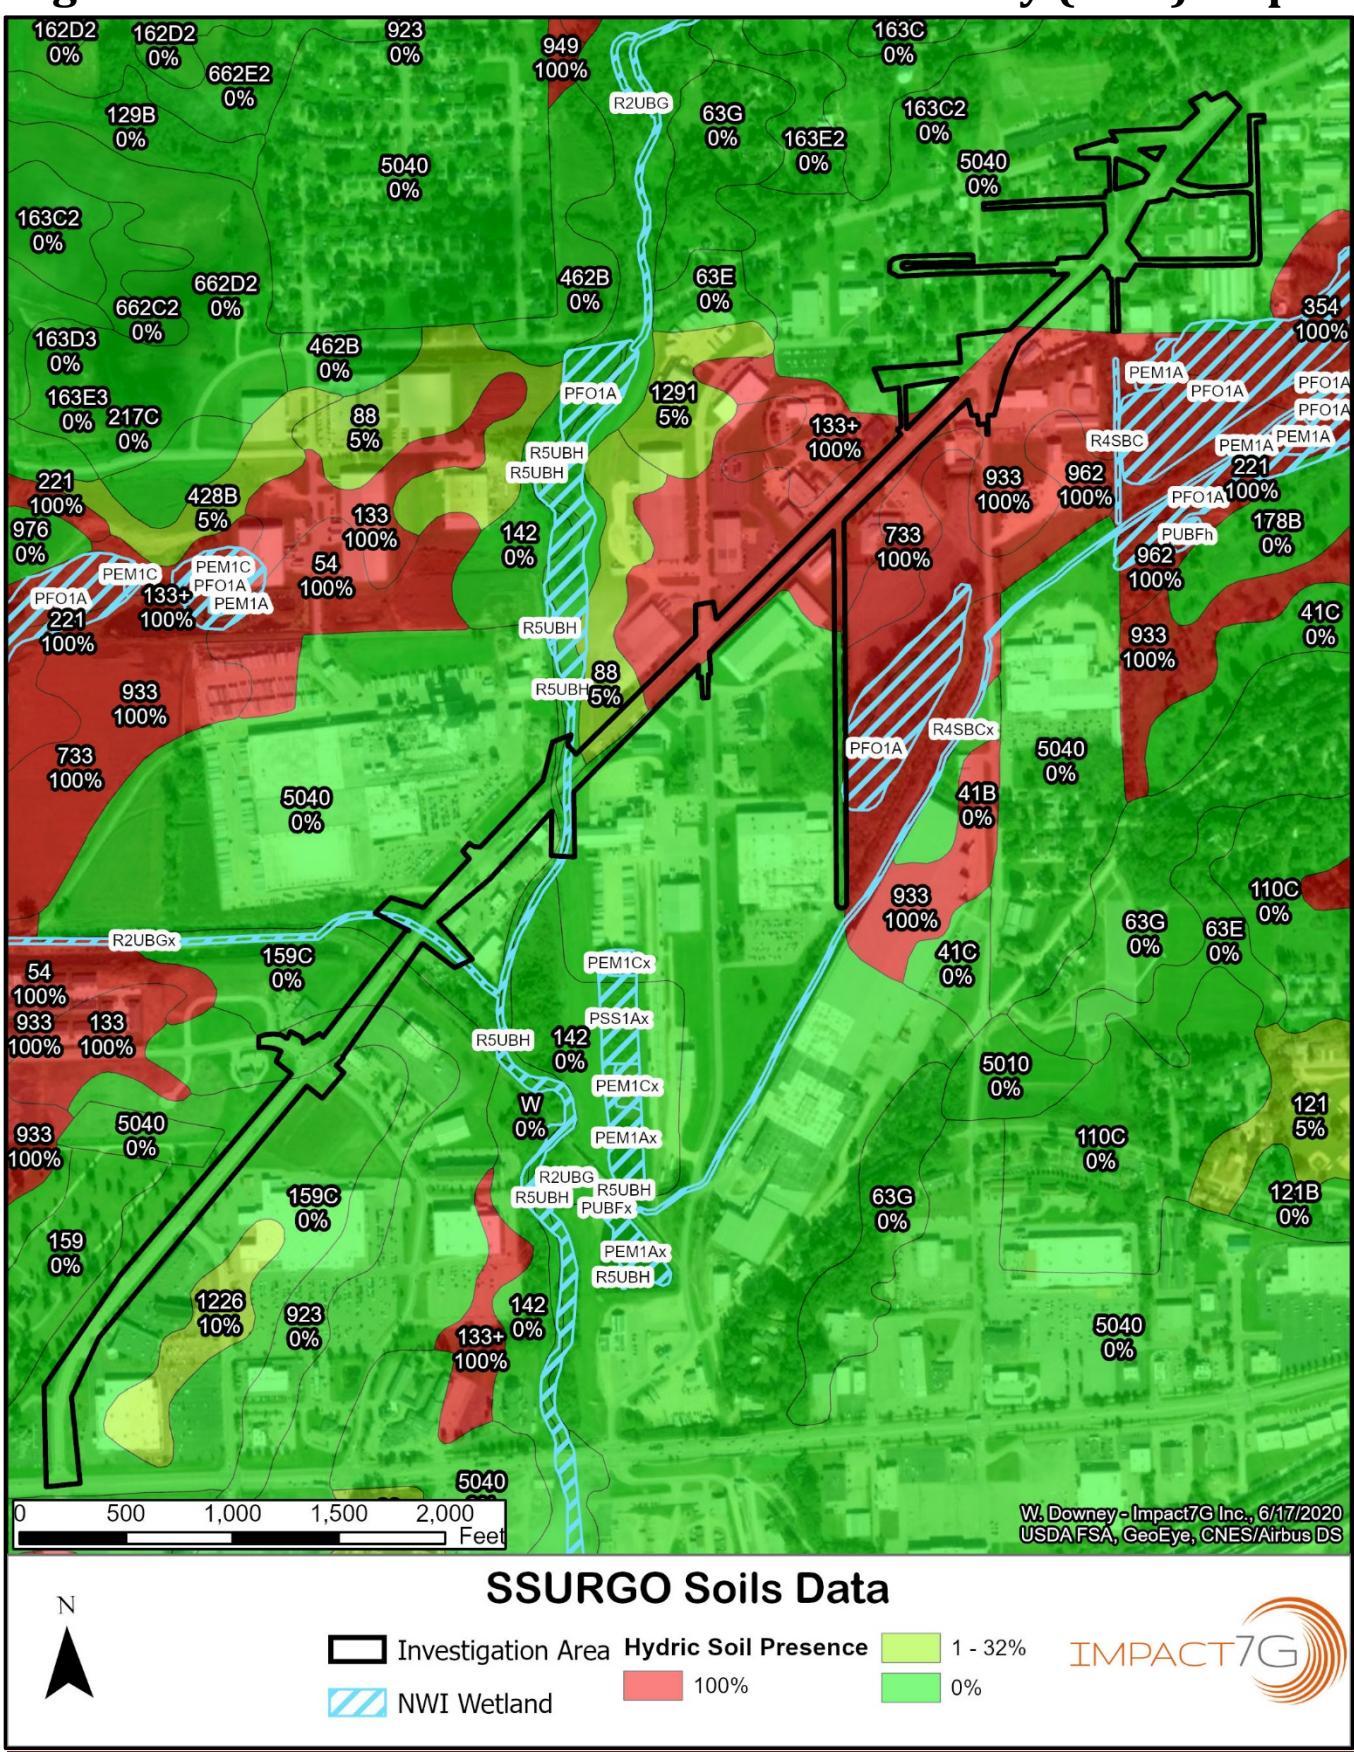
Figure D: Soils and National Wetland Inventory (NWI) Map

National Wetland Inventory (NWI) maps wetlands that overlap portions of the Investigation Area surrounding Mill Creek, Hart's Mill Creek, and a depressional area within a wooded corridor (Figure D). The majority of the Investigation Area is mapped as 0% hydric presence, but some areas northeast of Mill Creek mapped as NWI and along Manufacturing Drive are listed as 100% hydric presence (Figure D). Additionally, all sections of the Investigation Area excluding its northeastern most extent, lie within the regulatory floodway, the 1% or 0.2% annul chance flood hazard, are within an area of reduced flood risk due to an existing levee (Figure E).

Hydric
MUSYM	Mapunit Name	Presence (%)
54	Zook silty clay loam, 0 to 2 percent slopes	100
88	Nevin silty clay loam, 0 to 2 percent slopes	5
121	Tama silt loam, driftless, 0 to 2 percent slopes	5
133	Colo silty clay loam, 0 to 2 percent slopes	100
142	Chaseburg silt loam, moderately well drained, 0 to 2 percent slopes	0
159	Finchford loamy sand, 0 to 2 percent slopes	0
160	Walford silt loam, 0 to 1 percent slopes	100
221	Palms muck, 0 to 3 percent slopes	100
249	Zwingle silt loam, 0 to 2 percent slopes	100
354	Aquolls, ponded	100
733	Calco silty clay loam, 0 to 2 percent slopes	100
923	Coyne fine sandy loam, 0 to 2 percent slopes	0
933	Sawmill silty clay loam, 0 to 2 percent slopes	100
949	Zwingle variant silty clay, 0 to 2 percent slopes	100
962	Elvira silty clay loam, 0 to 2 percent slopes	100
976	Raddle silt loam, 0 to 2 percent slopes	0
1226	Lawler loam, 0 to 2 percent slopes, rarely flooded	10
1291	Atterberry silt loam, benches, 1 to 3 percent slopes	5

5010	Pits, gravel	0
5040	Orthents, loamy	0
163E2	Fayette silt loam, 14 to 18 percent slopes, moderately eroded	0
662E2	Mt. Carroll silt loam, 14 to 18 percent slopes, moderately eroded	0
163E3	Fayette silty clay loam, 14 to 18 percent slopes, severely eroded	0
110C	Lamont fine sandy loam, 2 to 9 percent slopes	0
121B	Tama silt loam, driftless, 2 to 6 percent slopes	0
129B	Arenzville-Chaseburg complex, 1 to 5 percent slopes	0
133+	Colo silt loam, overwash, 0 to 2 percent slopes	100
159C	Finchford loamy sand, 2 to 9 percent slopes	0
162C2	Downs silt loam, 5 to 9 percent slopes, moderately eroded	0
162D2	Downs silt loam, 9 to 14 percent slopes, moderately eroded	0
163C	Fayette silt loam, 5 to 9 percent slopes	0
163C2	Fayette silt loam, 5 to 9 percent slopes, moderately eroded	0
163D3	Fayette silty clay loam, 9 to 14 percent slopes, severely erode	0
178B	Waukee loam, 2 to 5 percent slopes	0
217C	Ripon silt loam, 30 to 40 inches to limestone, 5 to 9 percent slopes	0

41B	Sparta loamy fine sand, 2 to 5 percent slopes	0
41C	Sparta loamy fine sand, 5 to 9 percent slopes	0
428B	Ely silt loam, 2 to 5 percent slopes	5
462B	Downs silt loam, terrace, 2 to 5 percent slopes	0
63E	Chelsea loamy fine sand, 9 to 18 percent slopes	0
63G	Chelsea loamy fine sand, 18 to 25 percent slopes	0
662C2	Mt. Carroll silt loam, 5 to 9 percent slopes, moderately eroded	0
662D2	Mt. Carroll silt loam, 9 to 14 percent slopes, moderately eroded	0
W	Water	0

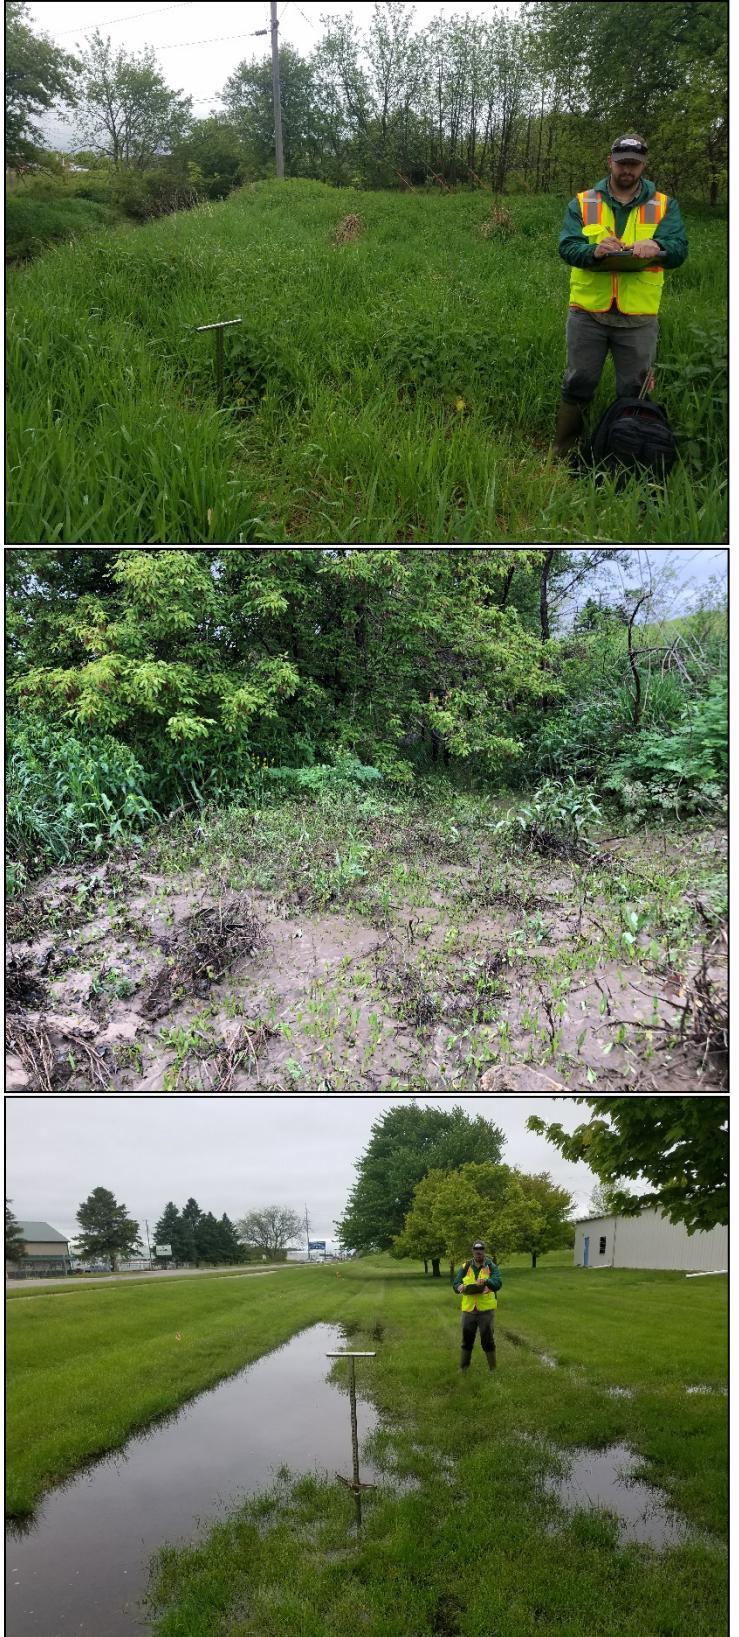
Photo 1: Perennial Stream Terrace Data Point 4-01 Date: 5/18/2020 Direction: Facing west

Photo 2: Emergent Wetland Data Point 4-02 Date: 5/18/2020 Direction: Facing north

Photo 3: Wet Ditch Data Point 4-03 Date: 5/18/2020 Direction: Facing southwest

Emergent wetland areas include reed canary grass-dominated low-landscape areas along stream terraces within the floodplain of Mill Creek and its associated tributary (data point 4-02). Emergent wetlands are unforested within the delineated boundary, but have some overhanging floodplain forest tree canopy, as well as surrounding sediment deposits. Adjacent upland areas near delineated wetlands contain hydrophytic vegetation but lack hydric soils and hydrology indicators.

The data	point is 15 feet fro	om a strea	m's edg	e, which	is flowing	10 feet b	elow gro	und elevation	n. Light rair	nfall occurred o	during sampling.

Hydrology	Remarks:												
Surface s	aturation is due to	o recent ra	Infall. Sedimen	t deposits a	ire prese	nt on sur	rounding vege	etation.

Ponded water lies over some areas of kentucky bluegrass.

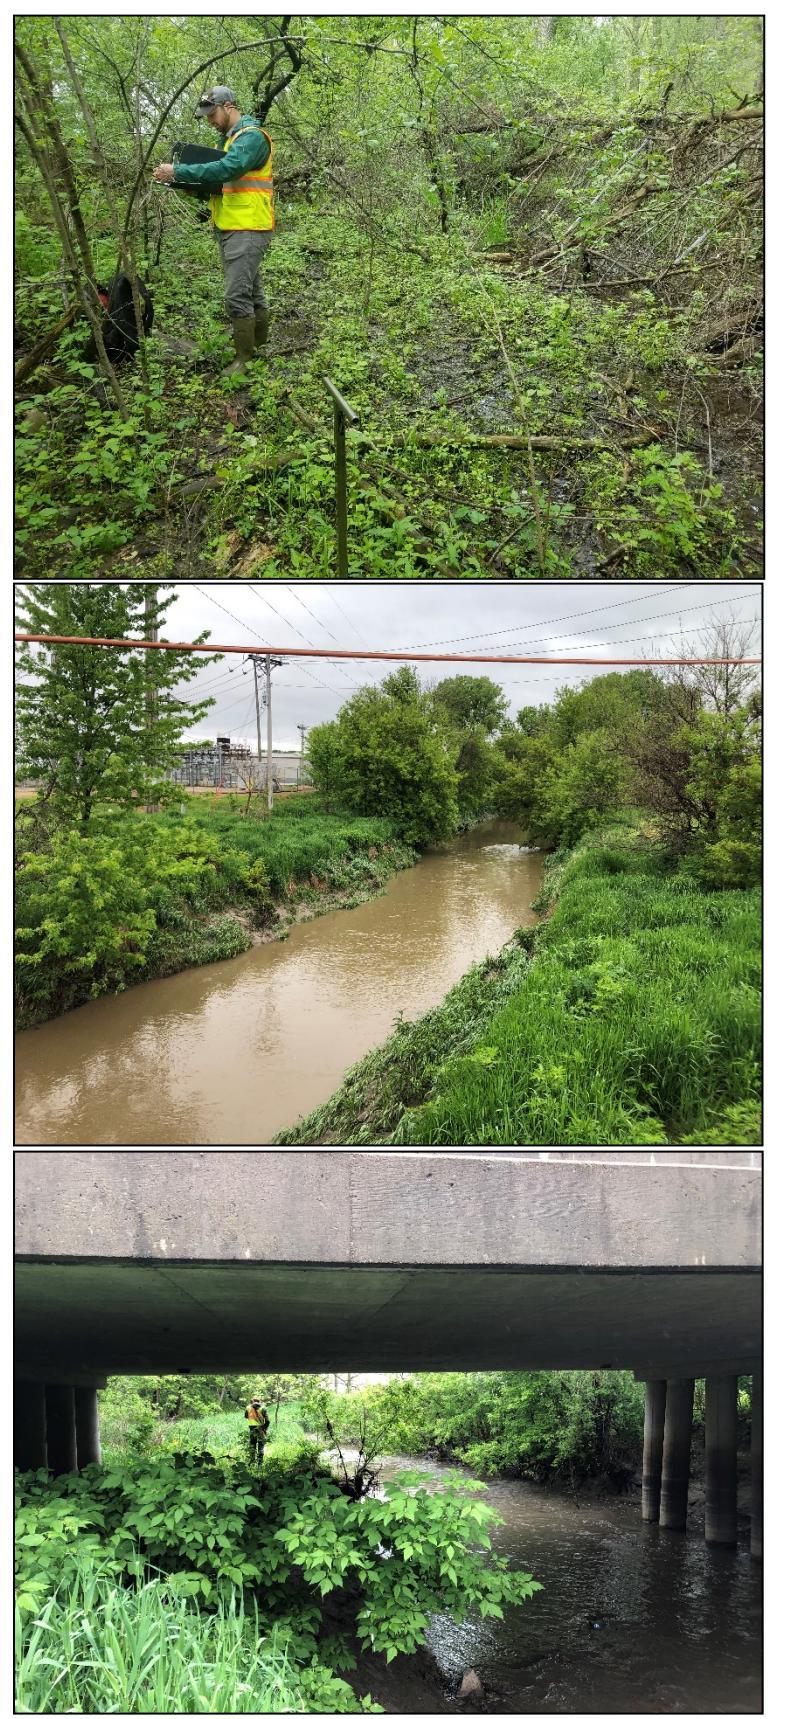
Photo 4: Forested Wetland Data Point 4-04 Date: 5/18/2020 Direction: Facing north

Photo 5: Mill Creek Date: 5/18/2020 Direction: Facing north

Photo 6: Hart's Mill Creek Date: 5/18/2020 Direction: Facing northwest

Forested wetlands consist of floodplain forests dominated by ash-leaf maple in the tree stratum and Canadian clearweed in the herbaceous stratum (data point 4-04). Located within the regulatory floodway and within or surrounding areas mapped as NWI, these areas are subject to periods of inundation and display saturation within the upper 12 inches of the soil.

- 564 linear feet
- 30 feet average width
- 4 feet general depth
- 2 feet water depth
- Well connected to floodplain
- Silt, Sand, Gravel substrate
- Silt, Sand bank material
- Moderately Functional because it is neither fully functional or functionally compromised

- 501 linear feet
- 25 feet average width
- 7 feet general depth
- 1.5-2.5 feet water depth
- Not connected to Floodplain, Moderately Incised
- Silt, Sand, Cobble, Gravel substrate
- Silt, Sand, Cobble, Gravel bank material
- Functionally Compromised

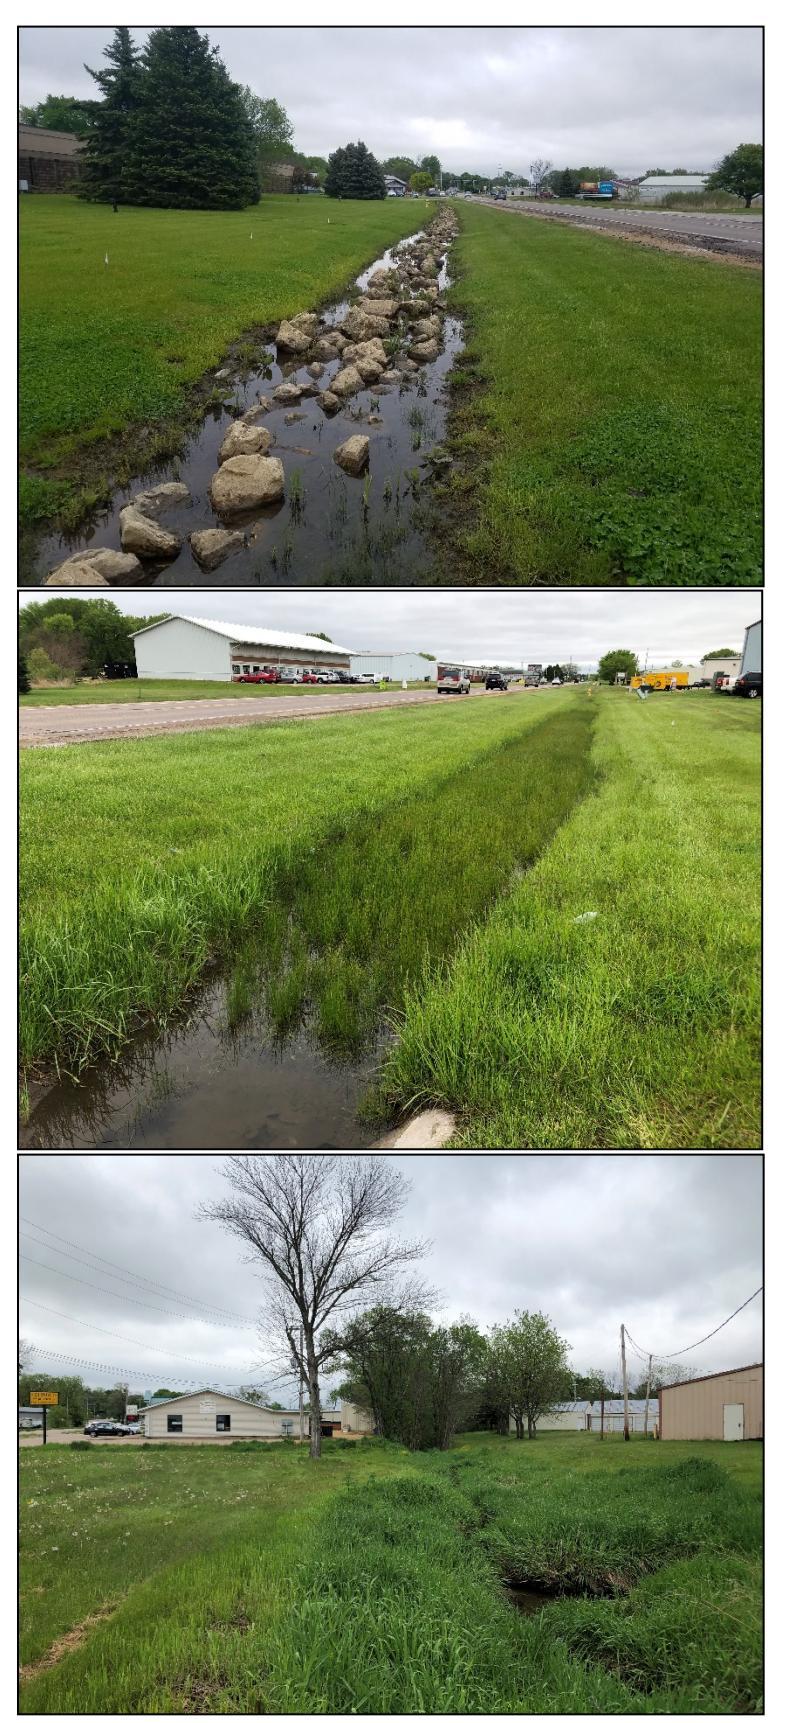
Photo 7: Drainage Ditch Date: 5/18/2020 Direction: Facing northeast

Photo 8: Wet Ditch Date: 5/18/2020 Direction: Facing southwest

Photo 9: Wet Ditch Date: 5/18/2020 Direction: Facing north

Any areas identified as Ditches within the investigation area were specifically designed and are maintained to promote roadway or other drainage. Ditches exhibiting wetland characteristics (hydrophytic vegetation, hydric soils, or wetland hydrology), that were constructed in upland areas are not identified as wetlands or other waters of the U.S. For the purposes of this report, ditches or portions of ditches meeting wetland characteristics that were likely constructed in pre-existing wetlands and/or intersect existing wetlands, or
